# SECONDARY CHANNEL STUDY OF WAY METEN IRRIGATION AREA, WAY APU SUB-DISTRICT, BURU DISTRICT, MALUKU PROVINCE

Construction Project Management  
Ambon State Polytechnic  
Indonesia.

**Abstract-** Performance is a description of the level of achievement of the implementation of a program of activities or policies in realizing the objectives. The purpose of this study is to determine the physical condition of the secondary channel, obtain the performance of the secondary irrigation channel building function and obtain the amount of maintenance implementation costs for the Way Way Meten irrigation secondary channel in Way Apu District, Buru Regency. Based on the results of research and analysis of calculations there is damage to the walls and floor of the channel Left Section Section (BA.Ki) 4 with Left Section Section (BA.Ki) 6, and the results of the Assessment of the performance index of the physical infrastructure of the carrier channel using the Regulation of the Minister of PUPR Number 12 / PRT / 2015 concerning Exploitation and Maintenance of Irrigation Networks, obtaining an assessment result of 59.80% in section Ba.Ki.4 and obtaining an assessment result of 57.05% in section

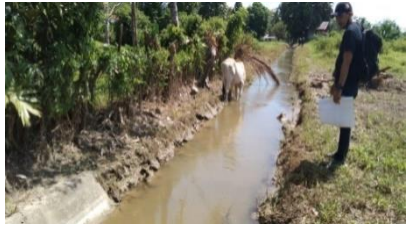
Left Section (BA.Ki) 6	g. There are cracks, longitudinal fractures on the floor and walls, growls (large holes), dry moss on the wall surface

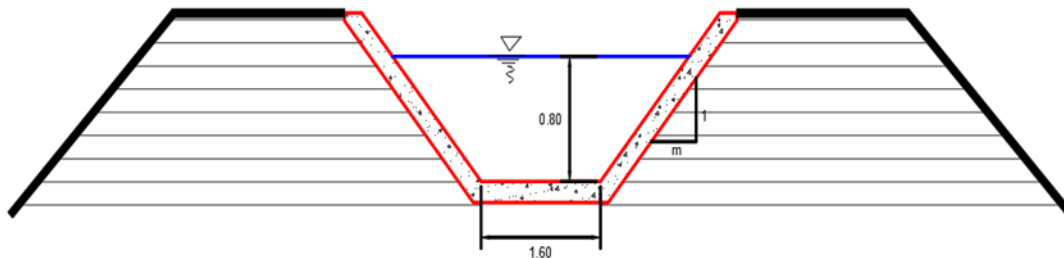
Figure 3 Upstream Secondary Channel

From the results of the above calculations, the Q obtained is 0.721 m<sup>3</sup>/sec and the plan Q is 1.287 m<sup>3</sup>/sec. The current Q does not meet the plan Q.

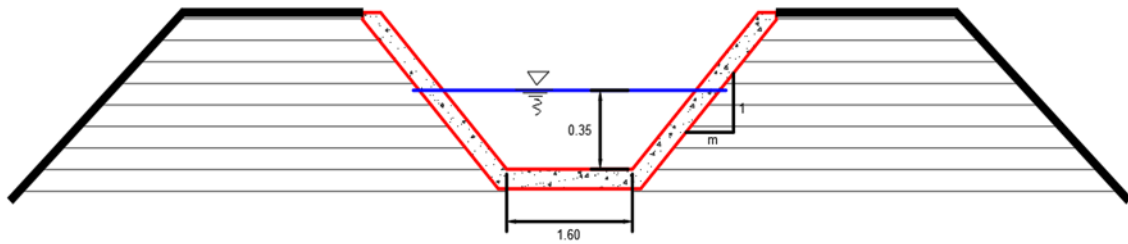
Figure 5 Upstream Secondary Channel

From the results of the above calculations, the Q obtained is 0.257 m<sup>3</sup>/sec and the plan Q is 1.119 m<sup>3</sup>/sec. The current Q does not meet the plan Q.
