# Identification and Improvement of Accident Black Spots on Kanpur-Lucknow & Lucknow-Faizabad including Shaheed Path (NH-25, NH-28 and NH-56A&B) Uttar Pradesh

<sup>1</sup>Shailendra Singh, <sup>2</sup>Shivam Singh Patel

<sup>1</sup>M.Tech Student (Highway Engineering), <sup>2</sup>Assistant Professor  
Department of Civil Engineering  
Maharishi University, Lucknow, India

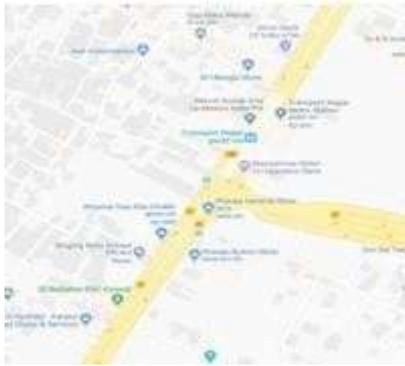
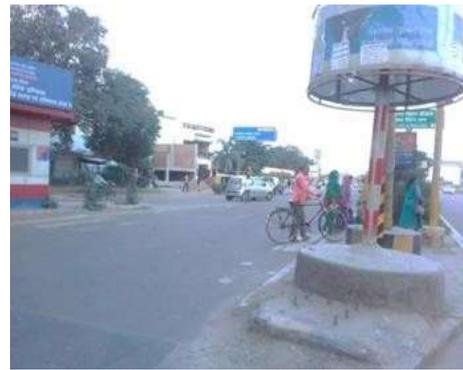
Based on the analysis of accident data top Two locations are discussed here: Location 1 :-

Black Spot ID	-	NH No	25	Location/Chainage	Km 11+005
Chainage	Km 08+000	Police Station	Sarojni Nagar	RO	UP East
Latitude	26.777059	Longitude	80.88222	PIU	Lucknow

Location of Black Spot: This Black Spot is 3 leg type of location of NH 56 A & B and NH 25. It is a 4 lane express highway for the traffic from Kanpur to Lucknow via Alambagh and Kanpur Road or Faizabad Road vice versa to go to other highways coming along the bypass. This merger point has huge traffic in this area due bus stop near this location. Heavy vehicle comes from the Kanpur to Lucknow or Faizabad.

The following measures have been provided in the location-

1. Pedestrian road marking should be done in the location.
2. Hazard marker and cautionary / inforamatory sign boards should be erected on the stretch
3. Median marker along with the kerb painting should be provided.
4. Street lighting should provide in the location.

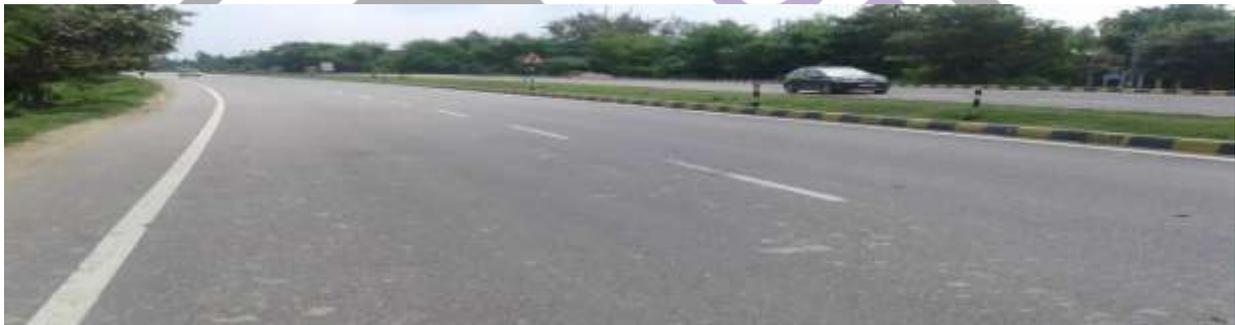
Location 2: -

Black Spot ID	-	NH No	28	Location/Chainage	Km 63+200
PWD Chainage	Km 62+900	Police Station	R.S. Ghat	RO	UP East
Latitude	26.8121	Longitude	81.51392	PIU	Lucknow

Location of Black Spot: - This Black Spot is a intersection, a village road joins the high speed corridor in hafahazard way. Traffic towards the village road joins the NH in wrongly manner and this merger points turns as frequent accident spot.

The following measures should provided in the location-

1. Pedestrian road marking in the location.
2. Hazard marker and median marker should be erected on location.
3. Advance Cautionary and Informatory Sign board must be installed on the location.
4. Median marker along with the kerb painting..
5. Solar blinker should be provided
